**Report**  
**Scratch resistance, chemical resistance and weathering**  
**resistance of a coating system of Optimum Car Care B.V.**

Report number: 89204199.1

Date: November 7<sup>th</sup>, 2013

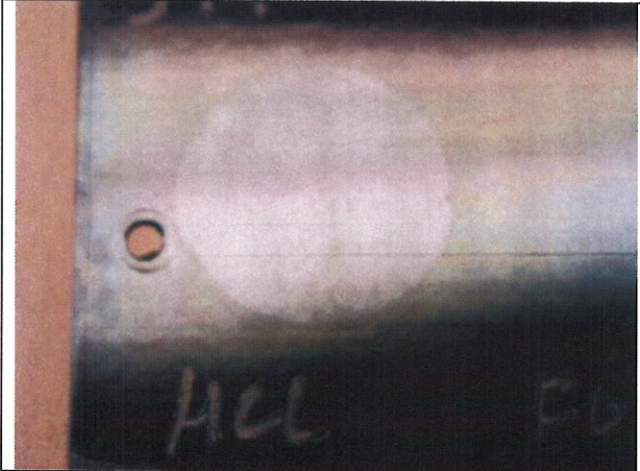
Chemical:	Results after		
	5 minutes	1 hour	24 hours
Concentrated hydrochloric acid (37%)	Some whitening of the surface	Stronger whitening	Whitening
Concentrated phosphoric acid (85%)	Intact	Slight discoloration and change in gloss	Severely damaged
Ethanol (96%)	Slightly increased gloss	Some wrinkling and swelling. After drying, the wrinkling and swelling become less pronounced, but remain clearly visible	Some wrinkling and swelling. After drying, the wrinkling and swelling become less pronounced, but remain clearly visible

Photo 1, After 5 min. of exposure to hydrochloric acid.	Photo 2, After 5 min. of exposure to phosphoric acid.

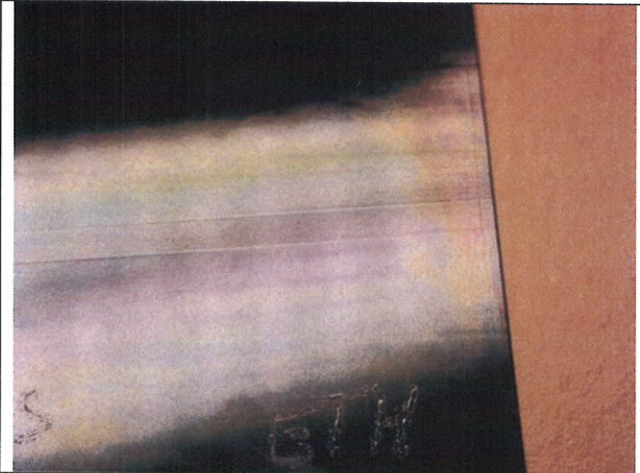
Photo 3, After 5 minutes of exposure to ethanol.

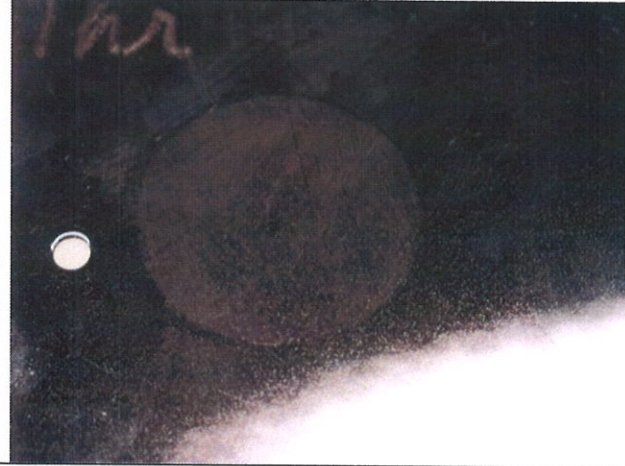
Photo 1, After 1 hour of exposure to hydrochloric acid.	Photo 2, After 1 hour of exposure to phosphoric acid.

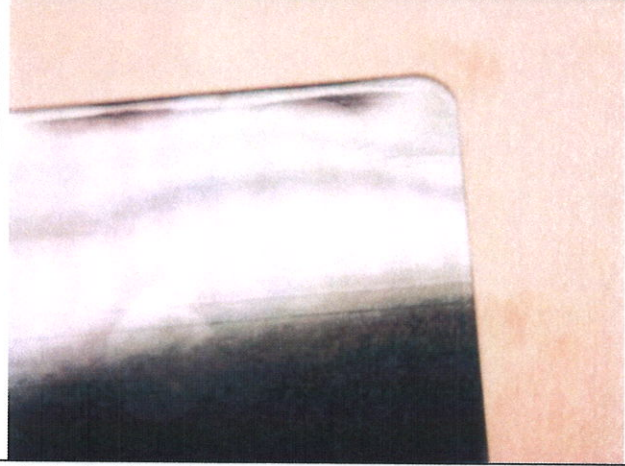
Photo 3, After 1 hour of exposure to ethanol.

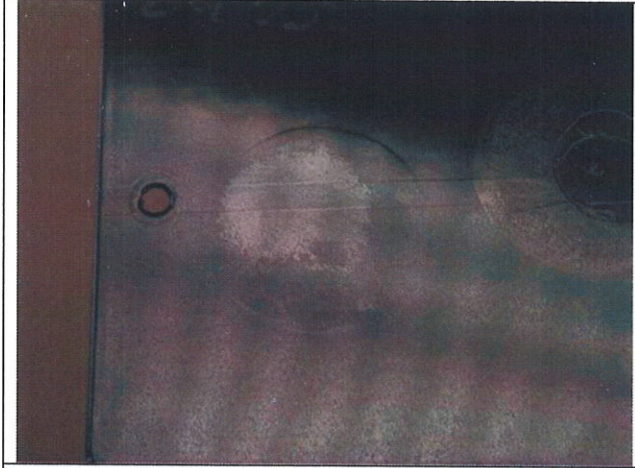
Photo 1, After 24 hrs. of exposure to hydrochloric acid.	Photo 2, After 24 hrs. of exposure to phosphoric acid.

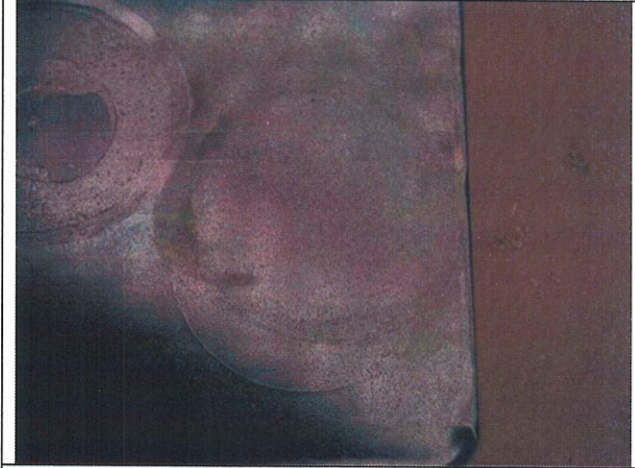
Photo 3, After 24 hrs. of exposure to ethanol.

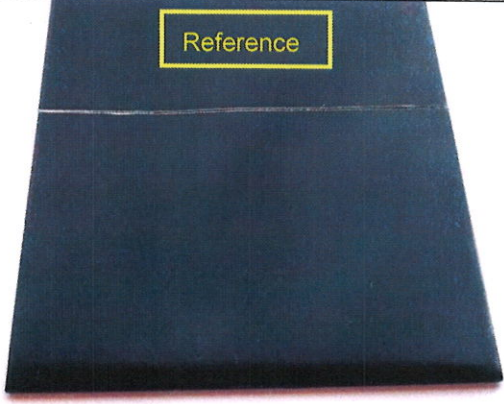
Photo 1, After 0 hrs. of artificial weathering.	Photo 2, After 500 hrs. of artificial weathering.

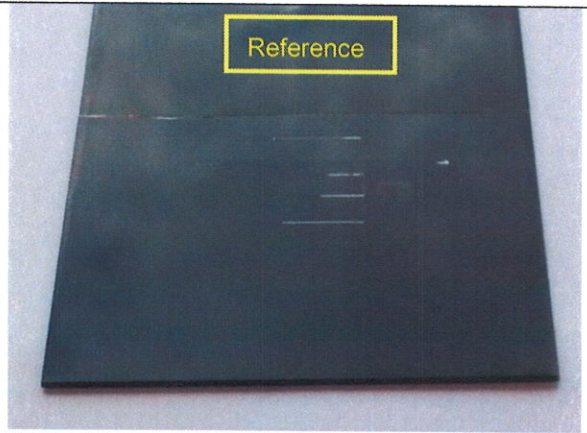
In the weathering test, the dark blue sample shows only a small loss of gloss and a very small discolouration ( $\Delta E < 0,25$  means that the discolouration is almost invisible).

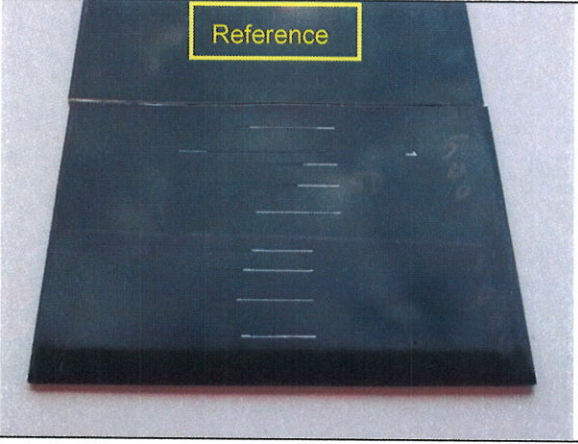
The scratch resistance however does show quite some changes. It is not clear whether this is a result of the weathering of the clear top layer or of the underlying dark blue layer. It is also likely that the coating might not have been fully cured at the beginning of the test and became harder and more brittle during the test (usually however, more cure means a higher resistance to scratching). Another possibility is that the thickness of the clearcoat shows some variations, thus explaining the deviations.

Photo 3, After 1,000 hrs. of artificial weathering.
